Mandatory Product Update/Safety Bulletin

PCU15-013 Safety Bulletin - BMU ONLY (Not in Americas) PC3/Titan Overspeed Safety Device October 30, 2015

SUB COMPONENT Overspeed Safety Device - Flywheel Assembly

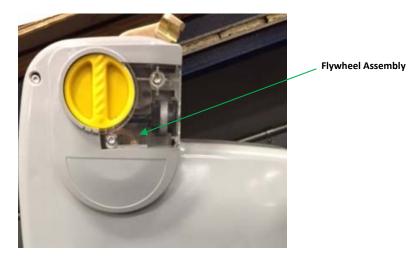
As outlined in the Power Climber Operators Manual, while powering the hoist "UP" and "Down" approximately 3 feet, look through the window near the Overspeed Brake Test Button to view that the flywheel is rotating. If the flywheel is not rotating or stops rotating during operation, hoist must be removed from service immediately.

- 2. If Flywheel Assembly passes inspection, the hoist may be used for up to 120 days as long as the Daily Test Requirements are performed as outlined in Power Climber Operators Manual.
- 3. If the Flywheel Assembly does not pass inspection, hoist must be removed from service until update has been applied.

1. A Flywheel Assembly update must be applied, please contact Service@PowerClimber.be or +32 3 451 05 00
